### Experimental study of tunnel segmental joints subjected to elevated temperature

# Experimental Study of Tunnel Segmental joints Subjected to Elevated Temperature

Zhiguo Yan <sup>a,b,c</sup>, Yi Shen <sup>a,b,c</sup>, Hehua Zhu <sup>a,b,c</sup>, Yong Lu <sup>d</sup>

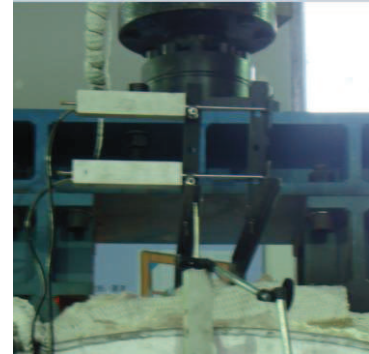
Principle

Test set-up

**Fig.4.** Measurement of opening angle of the lining joints

unexposed surface (in mm);  $\Delta L_1$  and  $\Delta L_2$  are the displacement increments of the first and the second LVDT, respectively (in mm);  $H$  is the thickness of the tunnel linings (in mm). It should be noted that the joint rotation and gap openings inferred from Eq. 2 included also the differential strain deformation between the inner and outer sides of the specimens over the measuring length. But relatively speaking these strain deformations were generally small as compared to the deformations at the joint gap and therefore they are neglected.

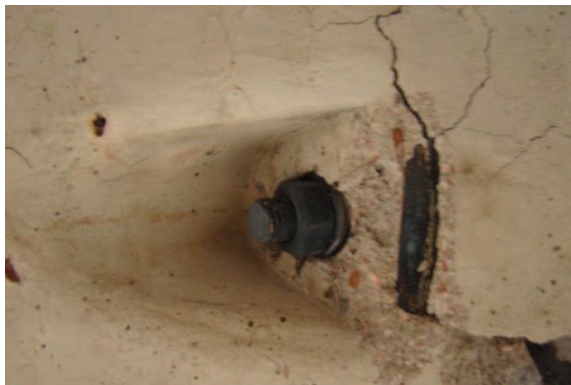
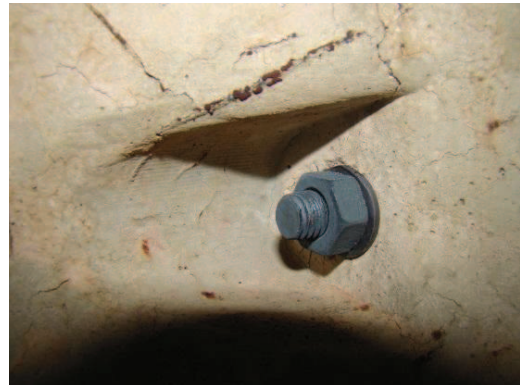
RC2

HFRC2

**Fig.7.** Spalling conditions around the handhole of RC and HFRC specimens

The severity of spalling was inspected after the test. **Fig.7** shows two typical cases of spalling around the handhole of the specimens, one for a RC specimen (RC2) and another for an HFRC specimen (HFRC2). For the RC specimen, the spalling zone expanded to the anchoring end of the bolt with a large piece of concrete removed, and it effectively exposed a part of the steel reinforcement around the handhole. This was a clear evidence of the detrimental effect that spalling can cause on the integrity of the RC joint. In contrast, for HFRC specimens, no visible spalling was found at the joint; and in fact the handhole even maintained intact after the bolt yielded due to mechanical loading. Such a superior spalling resistance in the HFRC specimens is deemed to be attributable to the presence of the polypropylene fibres in the mix of fibres used in the HFRC specimens. Polypropylene

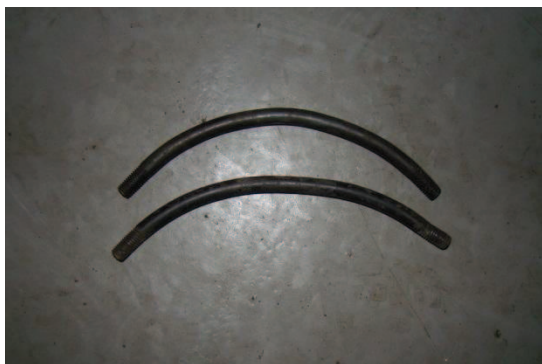
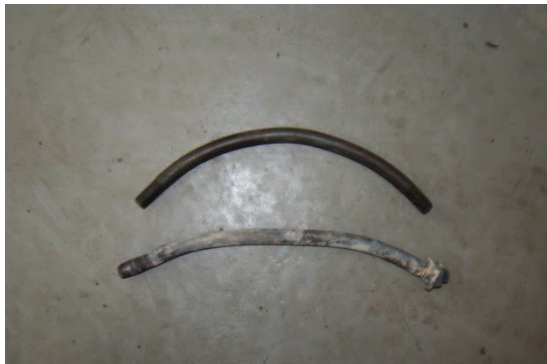
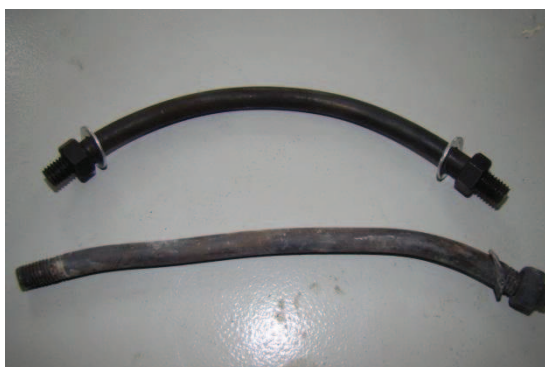
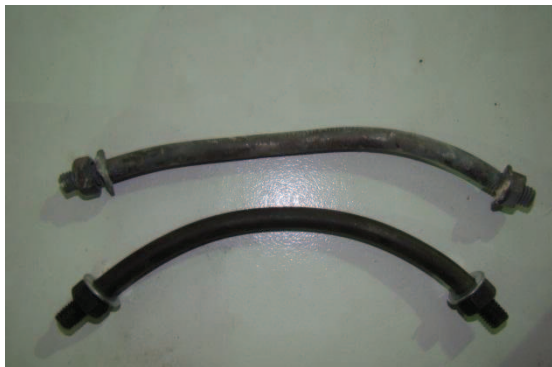
**Fig.8.** Comparison between deformed and original bolts from the specimens involving joint concrete failure

Three basic modes govern the failure of specimens, namely a) yielding of the joint bolts, b) failure of concrete at the joint, and c) failure of the segment. A summary of the individual failure modes of all test specimens is given in Table 5. As far as failure due to yielding of joint bolts is concerned, the failure of the bolts in the ambient cases and that in the under-fire cases exhibited rather different final patterns. The comparisons between the deformed bolts and un-deformed bolts in ambient and under-fire cases are illustrated in Fig.8. The bolts of HFRC specimens were highly oxidized and reacted chemically with the concrete contacting with it during fire. This resulted in the bolt showing light grey colour after the test. For cases with concrete failure occurred at the joint, the final distortions of the bolts were severe, as shown in Fig.8.

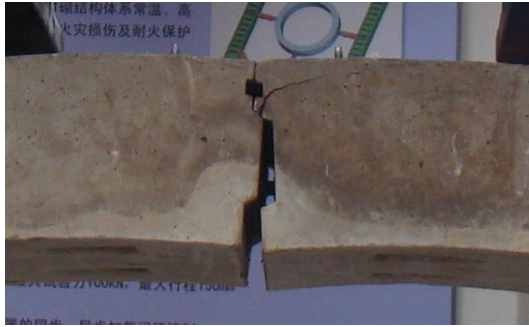
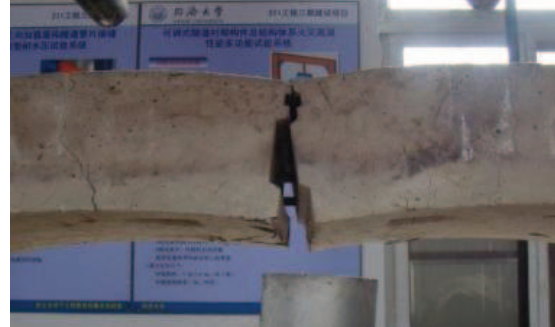
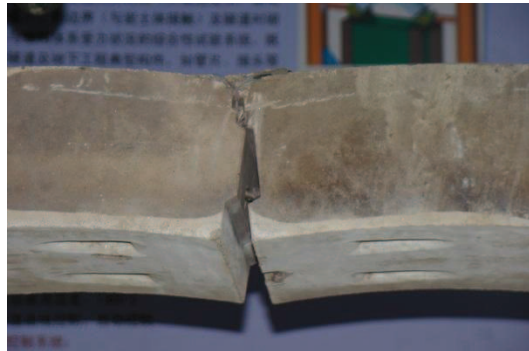
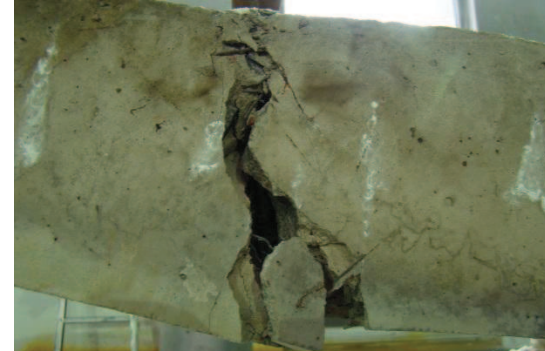
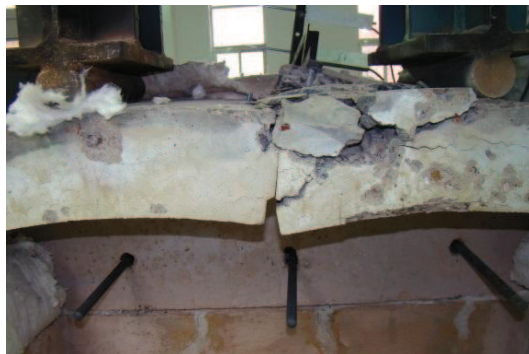
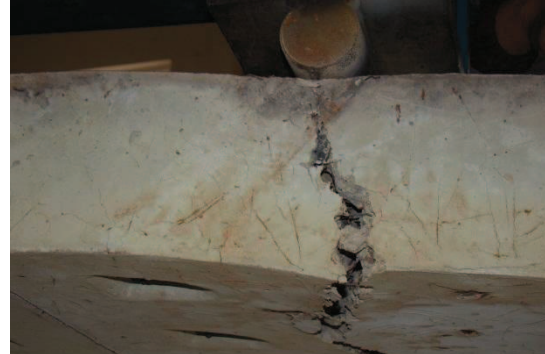
**Fig.9.** Failure modes of specimens tested at ambient temperature and under fire

Fig.9 (a) and (b) show the failure modes of the two specimens. The relationships of vertical load vs. vertical displacement at the joint, and bending moment vs. gap opening are

illustrated in **Fig.10 (a)** and **(b)**. Specimens RCJ1 exhibited a behaviour which was clearly dominated by the bending-rotation at the segment joint, and failed at the joint due to yielding of the curved bolts. As stretching and yielding of the bolts continued, the compression zone reduced, leading to crushing of the top edge concrete at the final stage (**Fig. 9 (a)**).

Specimen RCJ3 is directly comparable to the reference specimen RCJ1 as the mechanical loading conditions were the same except the fire effect. Similarly HFRCJ3 can be compared with HFRCJ1 directly. **Fig.14** shows the relationships of vertical load vs. vertical displacement and joint bending moment vs. joint opening gap for the two specimens. The final failure patterns are shown in **Fig.9 (a), (b), (e) and (f)**.

For another two pairs of specimens which were also tested under elevated temperature but with different levels of axial forces, namely RCJ2 & HFRCJ2 and RCJ4 & HFRCJ4, Fig.15 shows the vertical load vs. vertical displacement and joint bending moment vs. joint rotation relations. The corresponding final failure patterns are shown in Fig.9 (c), (d), (g) and (h). The results are summarized and discussed in what follows.

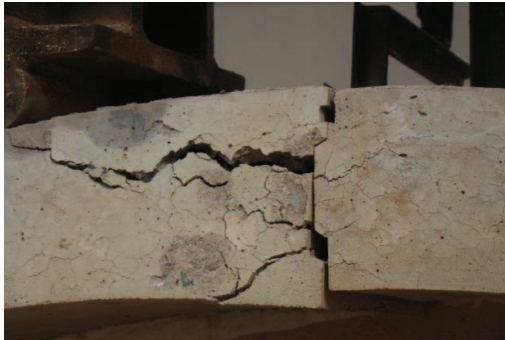
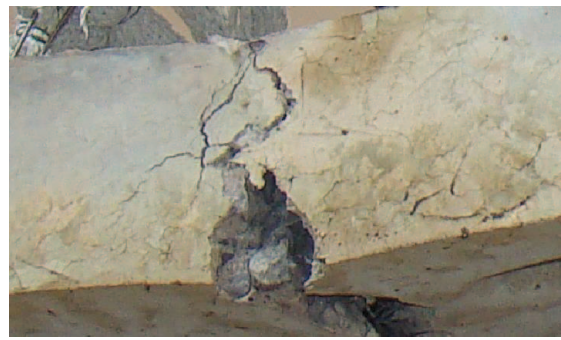
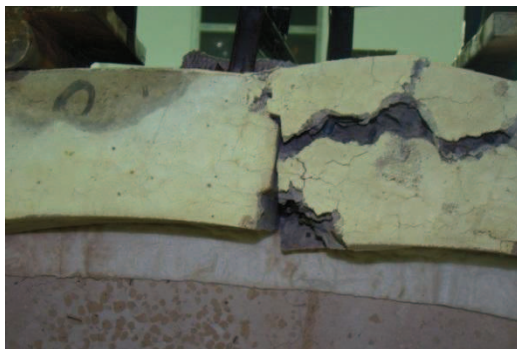
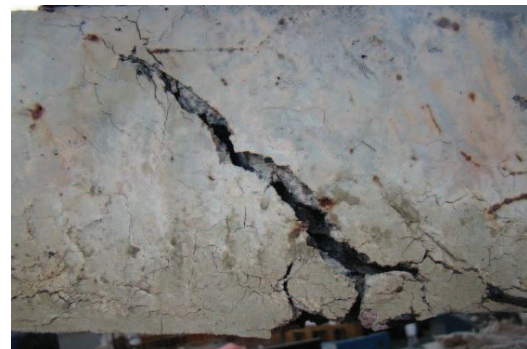
**Fig.18.** Failure modes of specimens from post-fire loading tests

The final failure patterns from post-fire loading tests are shown in **Fig.18**. The severer degradation in specimen RCJ5 at the joint region is clearly noticeable. Although specimen RCJ6 also failed eventually in compression at the joint region, the much less degradation in the compressive concrete from the heating, as also visible from the photo (**Fig. 18(c)**), helped the specimen to show a much higher resistance capacity. The failure patterns in the HFRC specimens tend to show some combined effects and this may be attributed to the characteristics of the HFRC sections in association to the higher uncertainties involved in the ultimate strength as discussed earlier in Section 4.2.

The above effects may be explained as follows. In the cases with an initial sagging moment, the joint opened wider on the heating side and this resulted in quicker heat transfer through the joint to the upper compressive concrete. The compressive concrete degraded under high temperature but consolidation took place at the same time; as a result, when the specimens were loaded in the post-fire testing, the specimens exhibited a stiffened behaviour, but failed in an abrupt manner and at a lower loading capacity due to the degradation of the compressive concrete during heating. On the contrary, in the cases with an initial hogging moment, the heated side was under compression, thus the joint opening on the heating side was reduced which effectively protected the upper layer of concrete in the joint region. When these specimens were subsequently tested under increased vertical
